Troubleshooting for UV unit

V. Cause and Action for alarm/trip relating to UV Chamber(unit)

G. UV intensity sensor fail

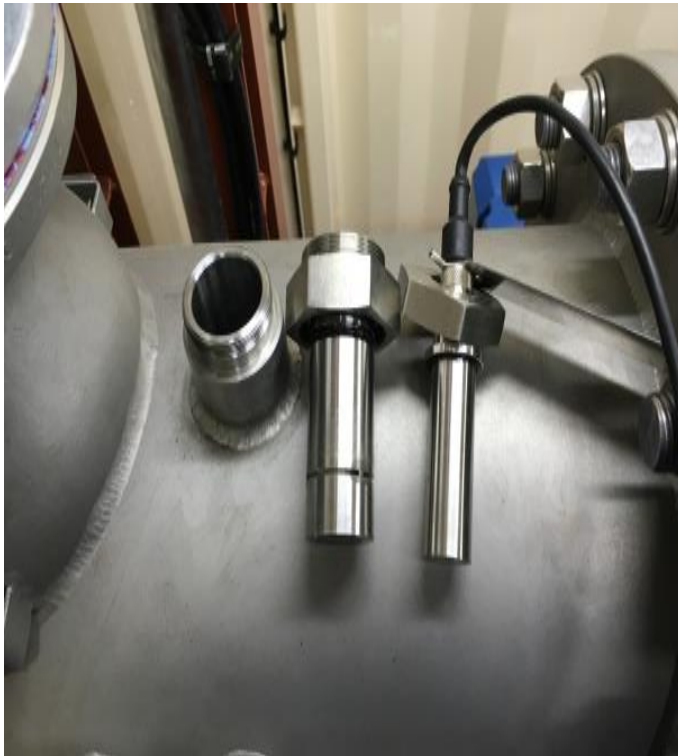
Action 1

Cause 1: UV Intensity Sensor Damage

Check the Pressure Transmitter.

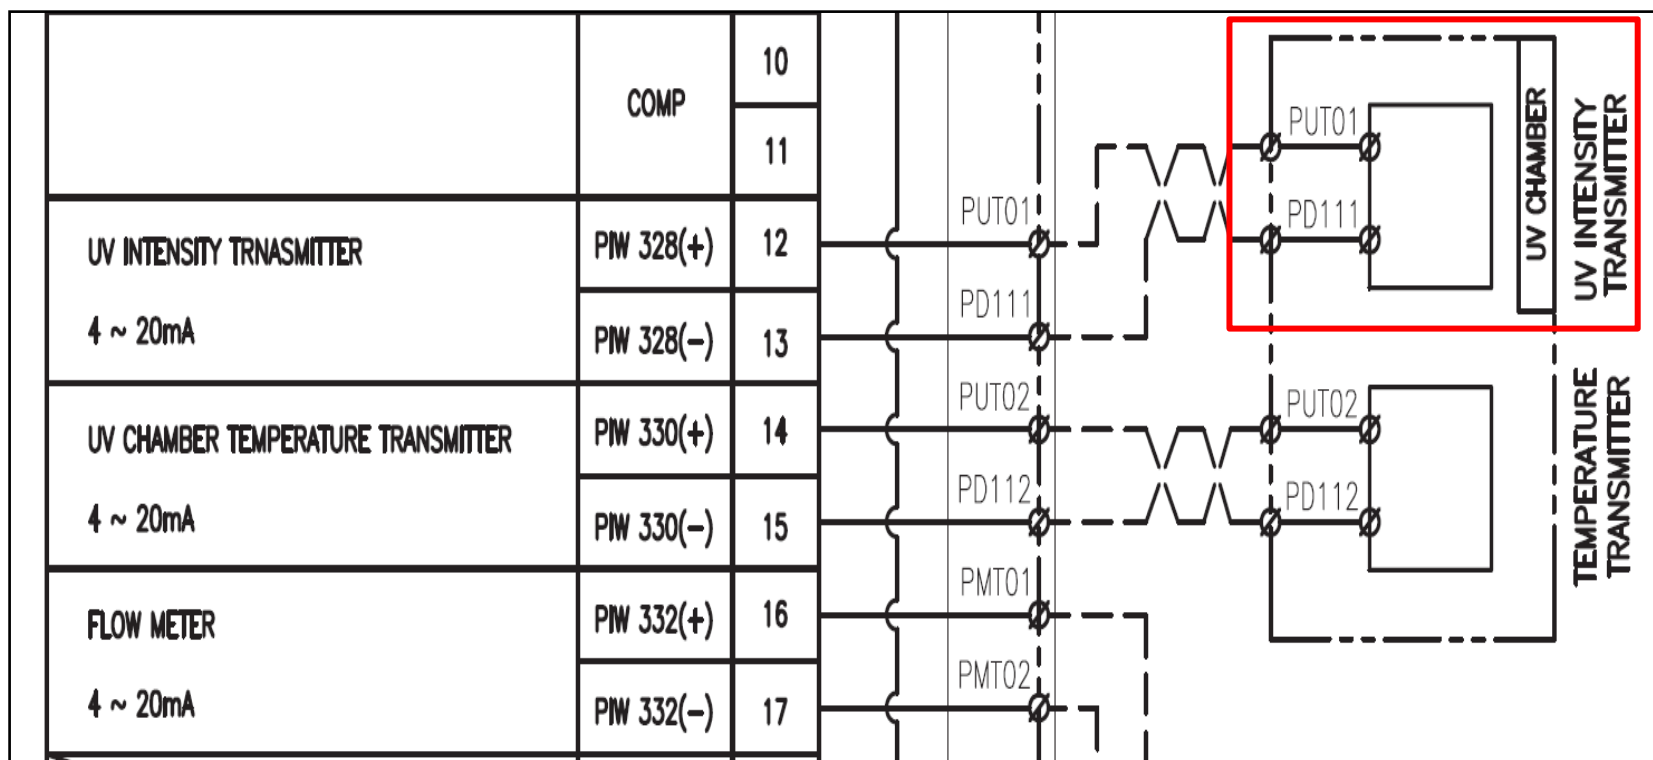
Action 1

Cause 2: Poor or wire connection

Check if all the electric wires are connected and tightened properly according to the electric drawings
