Troubleshooting for other components

IV Cause and Action for alarm/trip relating to Software & operating procedure

d. PLC RESPONSE TIME OUT

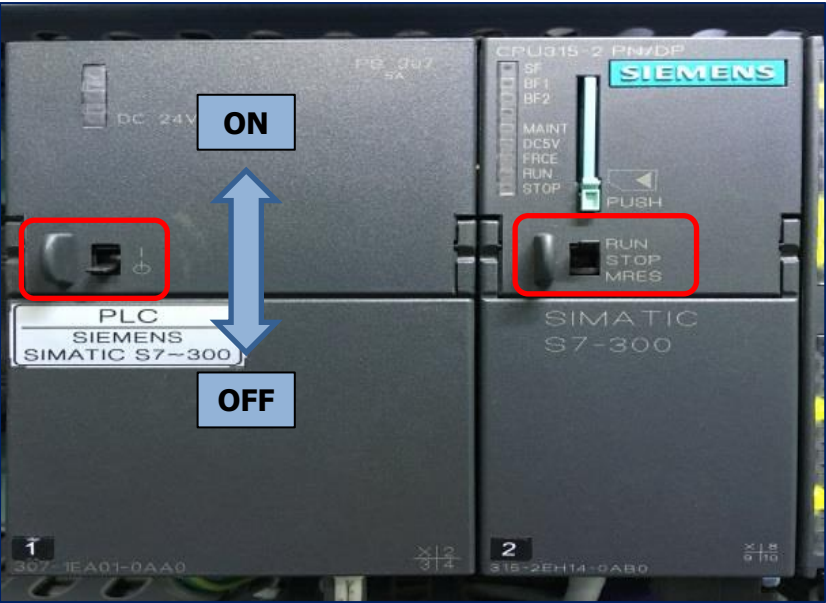
Action 1

Trip indicates that the PLC does not communicate with GP(Graphic Panel)

Verify the PLC is turned on
