Troubleshooting for UV unit

IV. Cause and Action for alarm/trip relating to UV Power Supply Panel

D. UV EARTH LEAKAGE CIRCUIT BREAKER TRIP

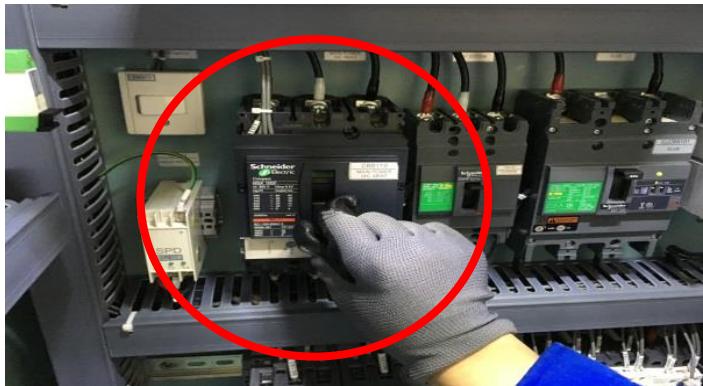
Action 1

Cause 1: UV Power Cable Insulation

1. Turn off Main CB(440V)

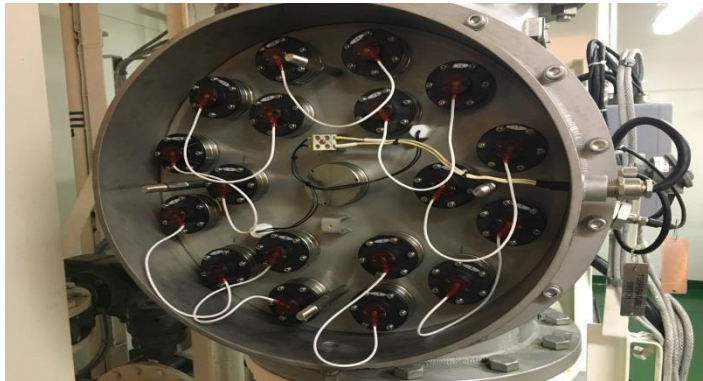
Action 1

Cause 2: Water leakage from broken Lamp Sleeve in the UV Chamber

1. Open UV Unit Side Cover and Dry out any moisture in side UV Unit
2. Unscrew bolts from Isolating Plate
3. Unscrew bolts connected with the UV lamp wires

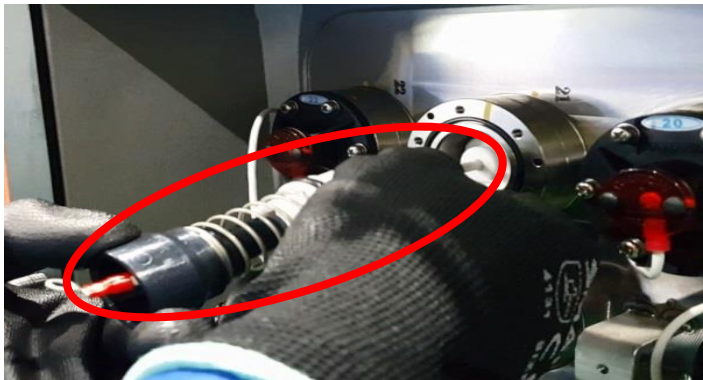
Action 4

Cause 2: Water leakage from broken Lamp Sleeve in the UV Chamber

4. Dismantle Anti-Vibration Module and UV Lamps

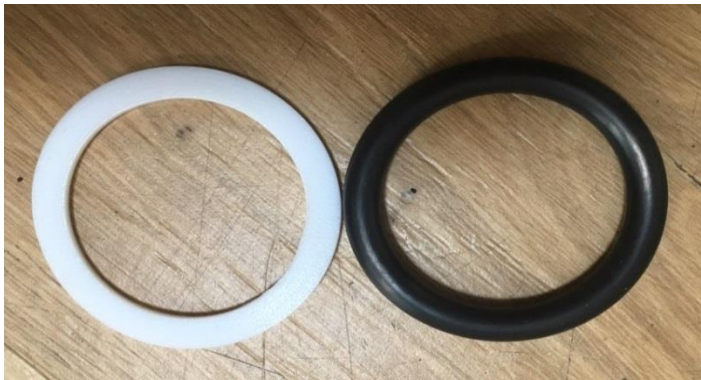
Action 7

Cause 2: Water leakage from broken Lamp Sleeve in the UV Chamber

7. Check the O-ring and tighten condition
